Bertram 60
"Sample"

Report of Marine Survey

Bertram 60

October 23, 2012

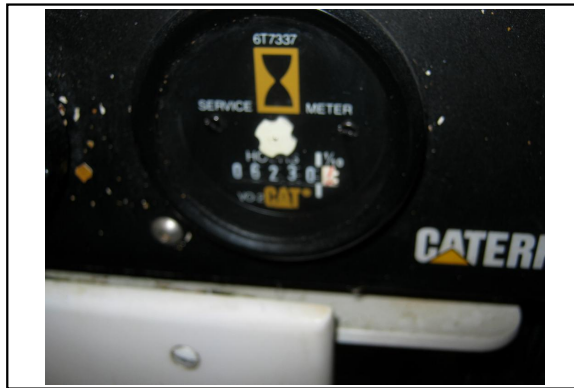
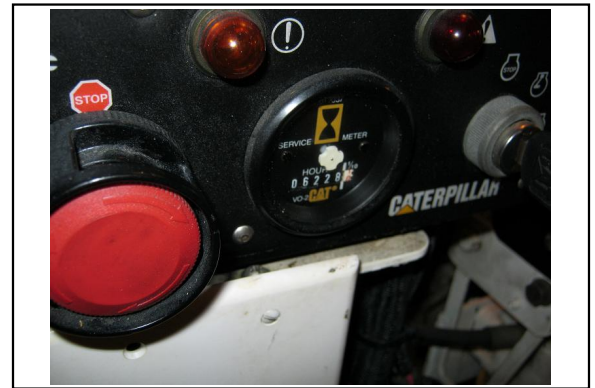
Port hours 6230. Starboard hours 6228.

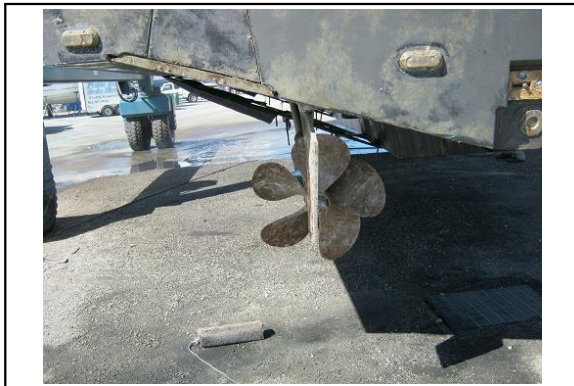
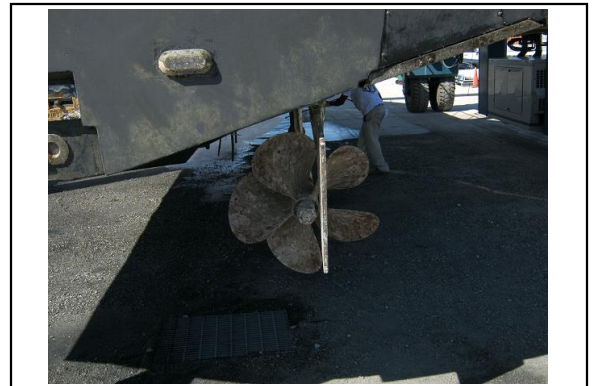
Two (2) bronze alloy, five bladed propellers.

Two (2) bronze alloy, five bladed propellers.	
FINDINGS	RECOMMENDATIONS
Starboard propeller has three (3) blades out of alignment.	<i>Recondition</i>
