Contender 31' Open Fish
"Sample"

Report of Marine Survey

Contender 31' Open Fish

September 11, 2012

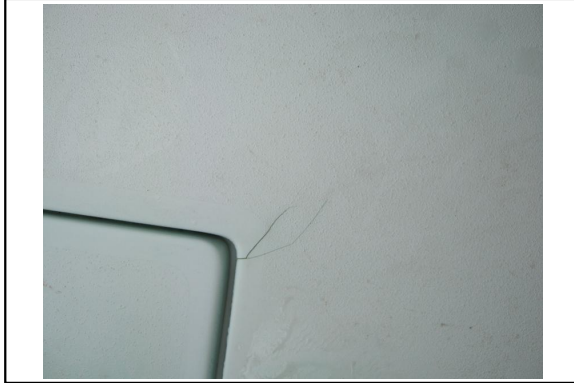
Contender 31 015.JPG

Cored FRP (fiber reinforced plastic) with white gelcoat, molded non-skid surface.

Cored FRP (fiber reinforced plastic) with white gelcoat, molded non-skid surface.	
FINDINGS	RECOMMENDATIONS
There are stress cracks on the deck in numerous spots.	<i>Monitor</i>

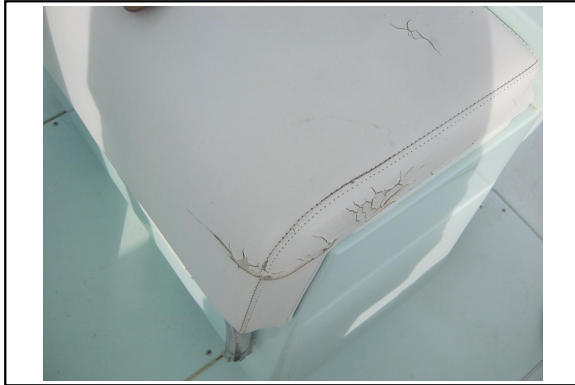
Contender 31 017.JPG

Bench seats.

Bench seats.	
FINDINGS	RECOMMENDATIONS
The bench cushions are torn.	Investigate further and repair or renew as necessary.

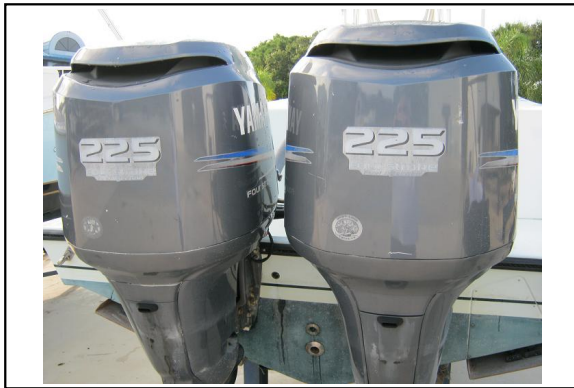
Contender 31 012.JPG

Two (2) Yamaha outboards 225 hp six cylinder V-6 gasoline naturally aspirated engines.

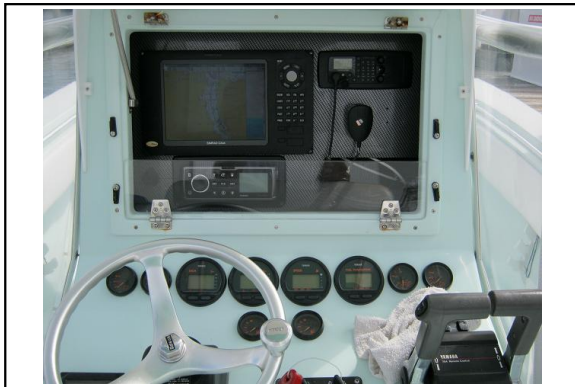
Contender 31 020.JPG

Simrad: RD65. Powers up.

Simrad: RD65. Powers up.	
FINDINGS	RECOMMENDATIONS
The VHF mic wire is frayed.	<i>Further investigate and repair as necessary.</i>

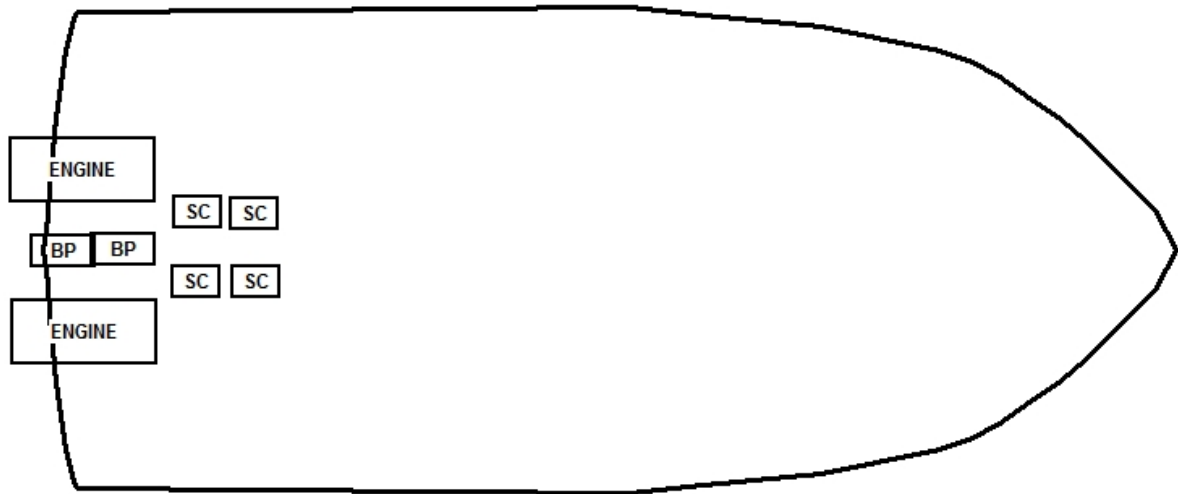
****Black Icon(s) with white text indicates inoperable item.**

Yes. Two (2) See thru-hull diagram.	
FINDINGS	RECOMMENDATIONS
Both aft bilge pump float switches are inoperable.	<i>Further investigate and repair as necessary.</i>
