Birely Marine Services Inc.
BIRELY MARINE SURVEYOR AND CONSULTANT

Report of Marine Survey

Yellowfin 42'

June 22, 2022

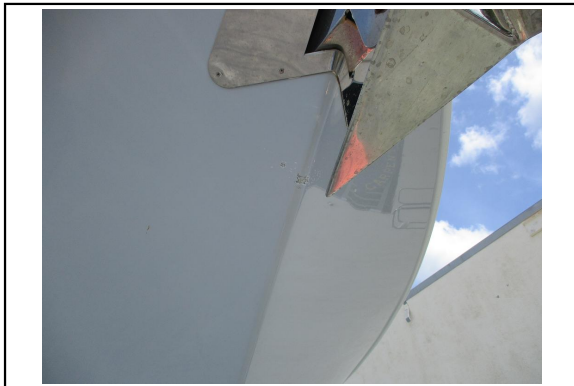
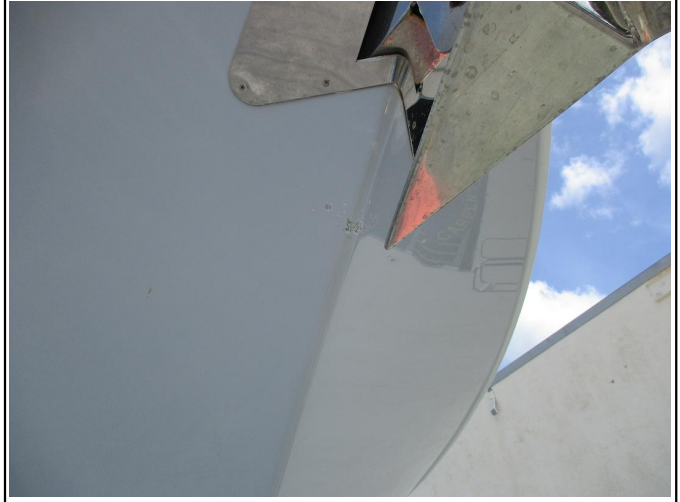
Yellowfin 056

***B.1**

Two of the wet surface chimes the gelcoat is chipped.

***C.1**

The boats bow has chips in the gelcoat.

FINDINGS	RECOMMENDATIONS
Two of the wet surface chimes the gelcoat is chipped.	Refinish

FINDINGS	RECOMMENDATIONS
The boats bow has chips in the gelcoat.	Further investigate and repair as necessary.

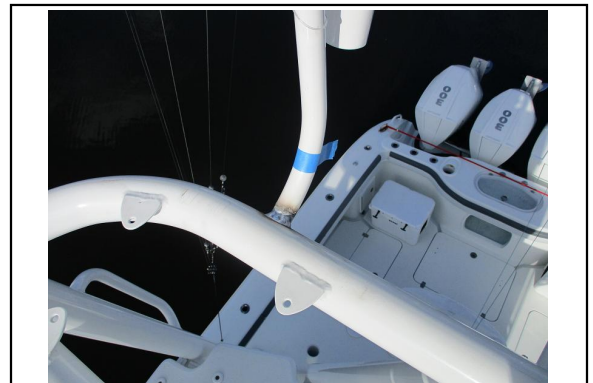
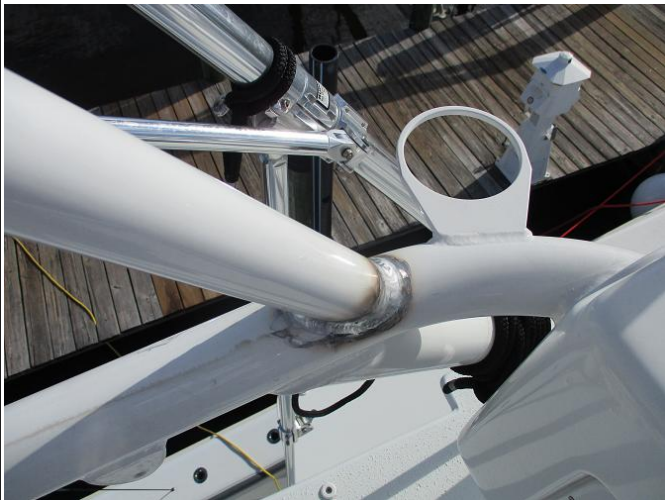
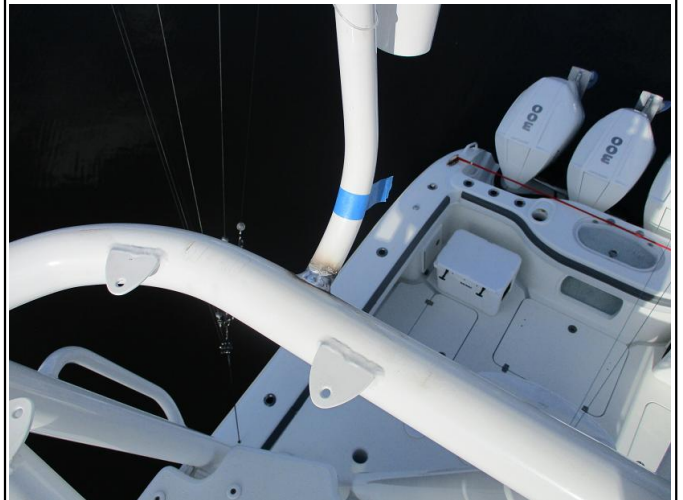
Yellowfin 032

***C.3**

The tower has two new welds that are not painted.

FINDINGS	RECOMMENDATIONS
The tower has two new welds that are not painted.	Refinish

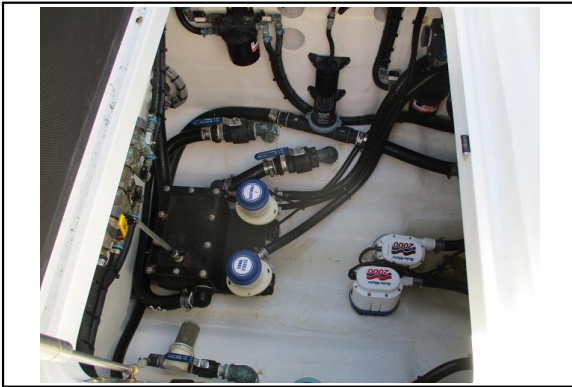
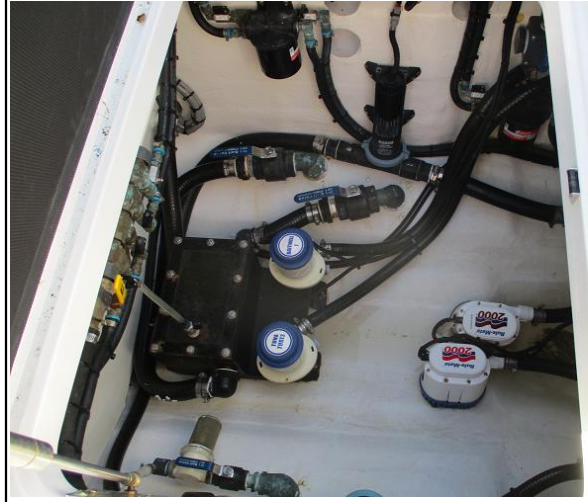
Yellowfin 007

***B.7**

The starboard fuel shut off valve is missing the handle.

FINDINGS	RECOMMENDATIONS
The starboard fuel shut off valve is missing the handle.	Install handle.

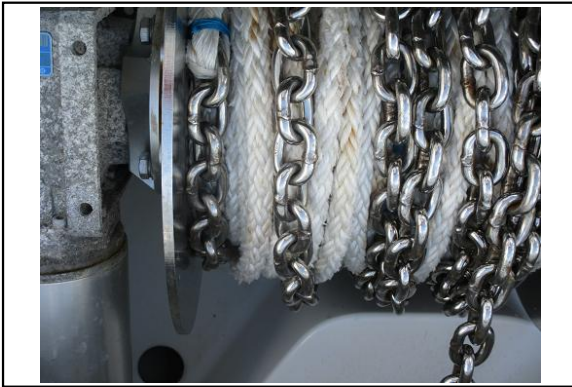
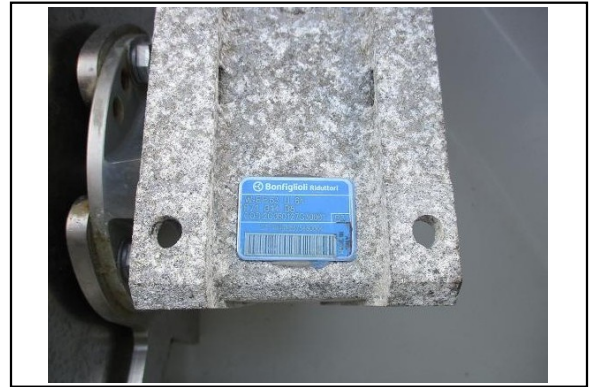
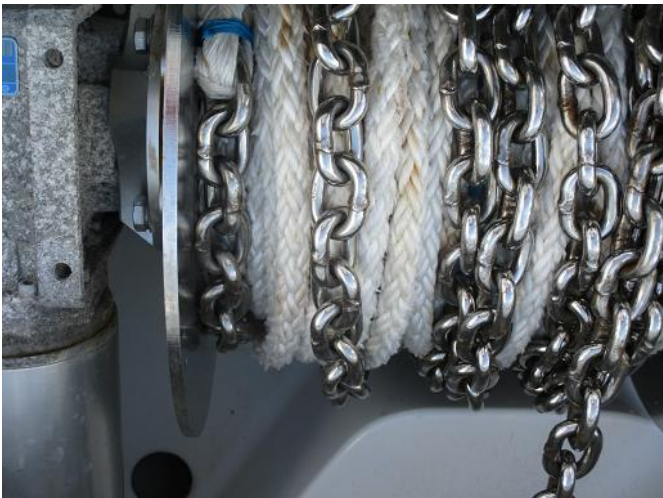
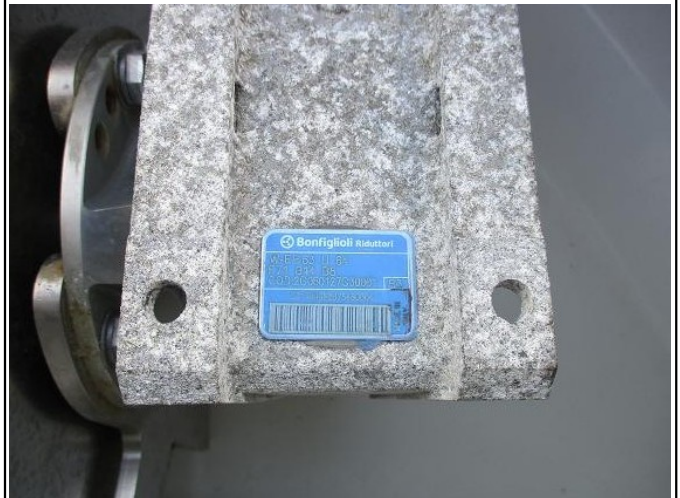
Yellowfin 014

***B.8**

Windlass control on deck is inoperable.

FINDINGS	RECOMMENDATIONS
Windlass control on deck is inoperable.	Further investigate and repair as necessary.

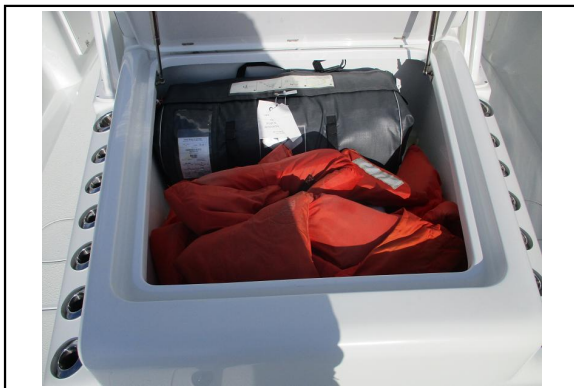
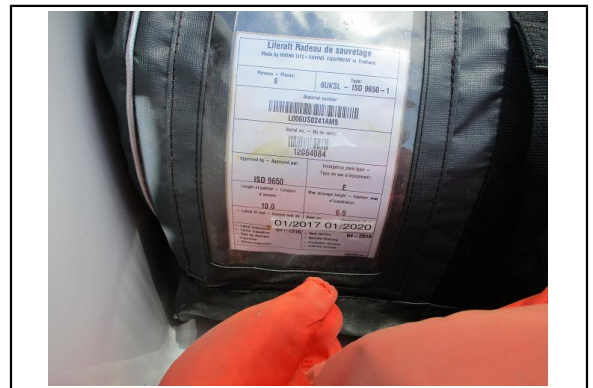
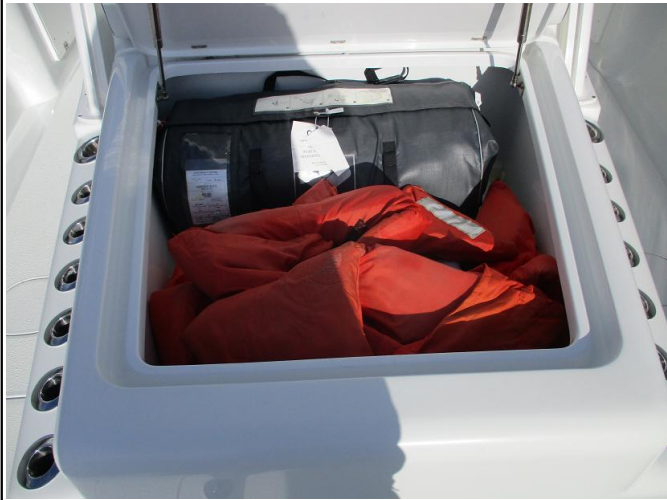
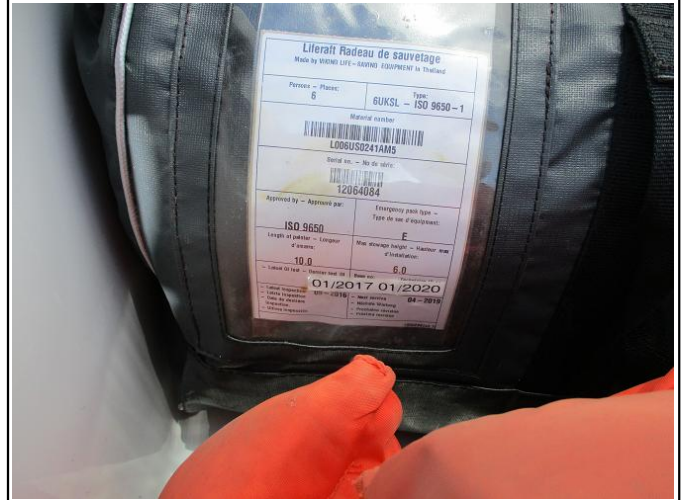
Yellowfin 016

***B.11**

Raft does not have a current inspection tag.

FINDINGS	RECOMMENDATIONS
Raft does not have a current inspection tag.	Have the life raft inspected and repacked by authorized personnel, mark and prepare stowage area for ready deployment.

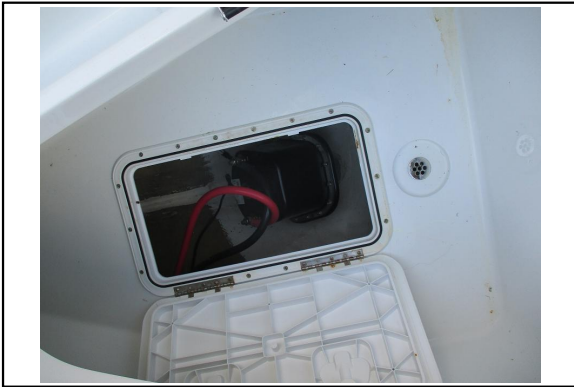
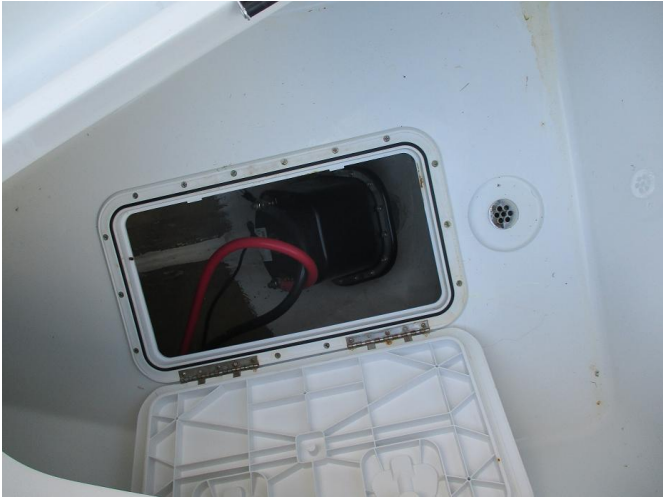
Yellowfin 012

***A.2**

The bow thruster positive connection is not covered.

FINDINGS	RECOMMENDATIONS
The bow thruster positive connection is not covered.	Further investigate and repair as necessary.
