Birely Marine Services Inc.
BIRELY MARINE SURVEYOR AND CONSULTANT

Hatteras 64' Motor Yacht

Report of Marine Survey

November 04, 2020

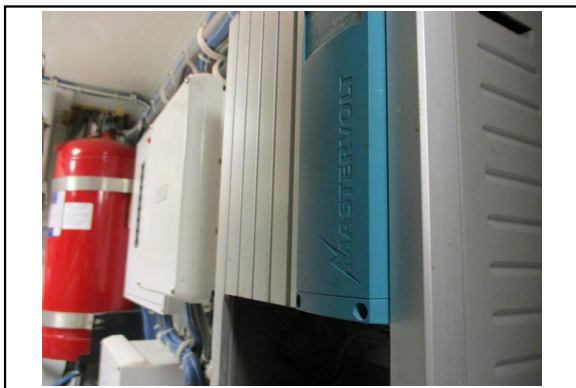
Hatteras 089

***B.1**

The battery charger bottom panel is missing.

FINDINGS	RECOMMENDATIONS
The battery charger bottom panel is missing.	Cover

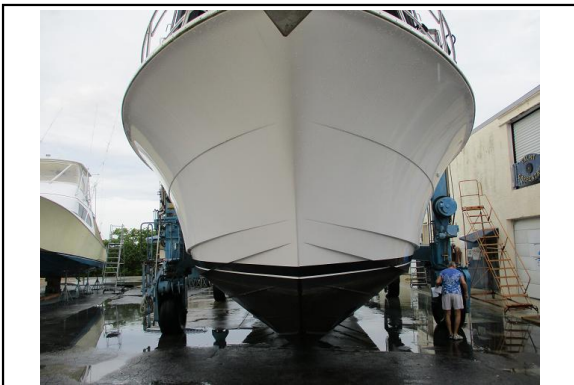
Hatteras 001

CONDITION OF BOTTOM PAINT:

Bottom well painted. Condition good.
