Birely Marine Services Inc.
BIRELY MARINE SURVEYOR AND CONSULTANT

Report of Marine Survey

Yellowfin 42'

June 22, 2022

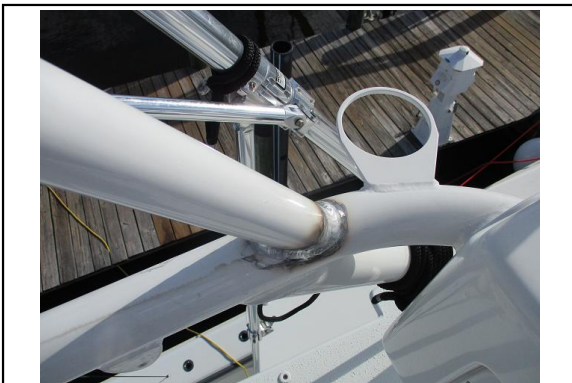
Yellowfin 031

***C.3**

The tower has two new welds that are not painted.
